DENEY SERTİFİKASI / Test Certificate

Numunenin Adı ve Tanımı / Sample's Name & Description: BG60 Inside Opening Hidden Vent In The Capped
Curtain Wall

TEST REPORT

Product / Project : BG 60 Inside Opening Hidden Vent In The Capped Curtain Wall

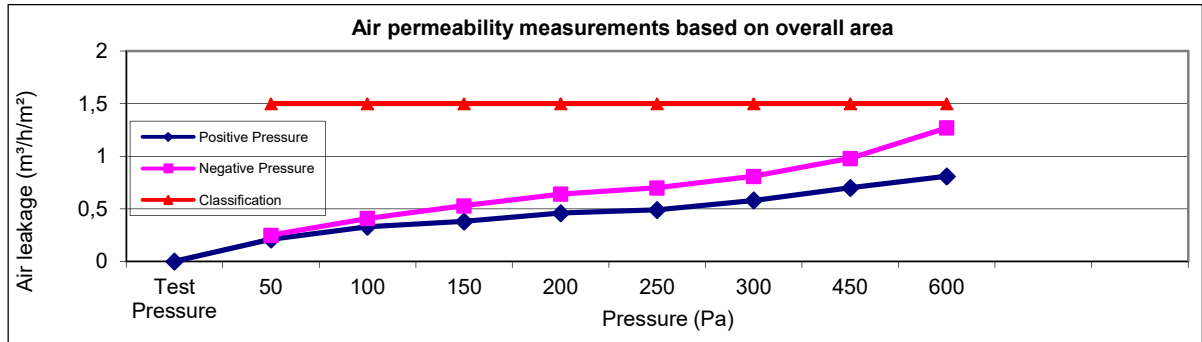
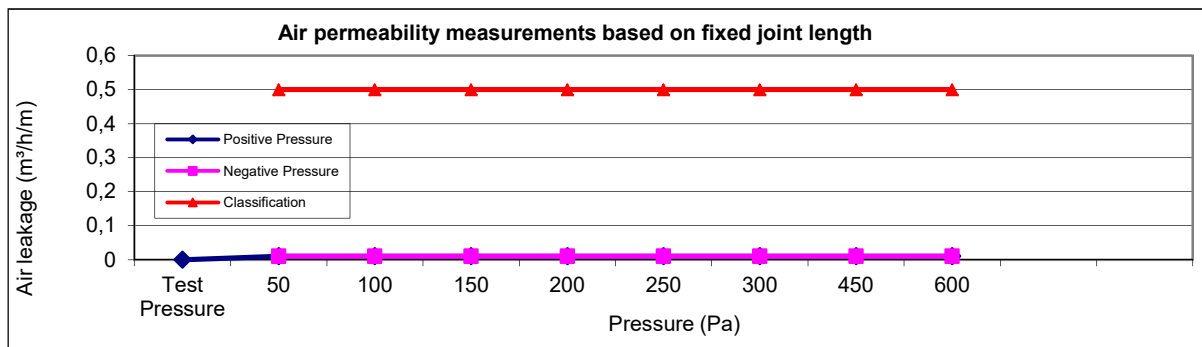
Air permeability measurements based on overall area;

POSITIVE PRESSURE		
Test Pressure (Pa)	Air Leakage (m ³ /h)	Air Leakage (m ³ /h/m ²)
50	1,70	0,21
100	2,65	0,33
150	3,02	0,38
200	3,66	0,46
250	3,89	0,49
300	4,61	0,58
450	5,60	0,70
600	6,48	0,81

NEGATIVE PRESSURE		
Test Pressure (Pa)	Air Leakage (m ³ /h)	Air Leakage (m ³ /h/m ²)
50	1,97	0,25
100	3,28	0,41
150	4,21	0,53
200	5,08	0,64
250	5,62	0,70
300	6,47	0,81
450	7,79	0,98
600	10,11	1,27

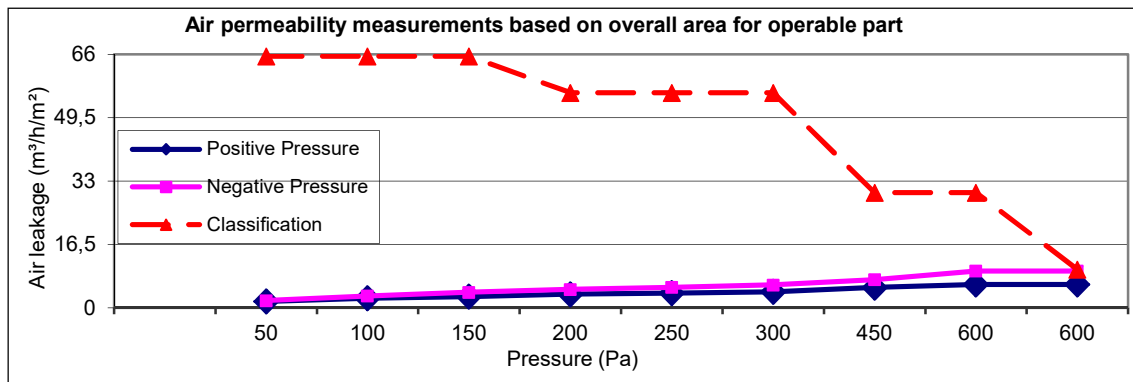
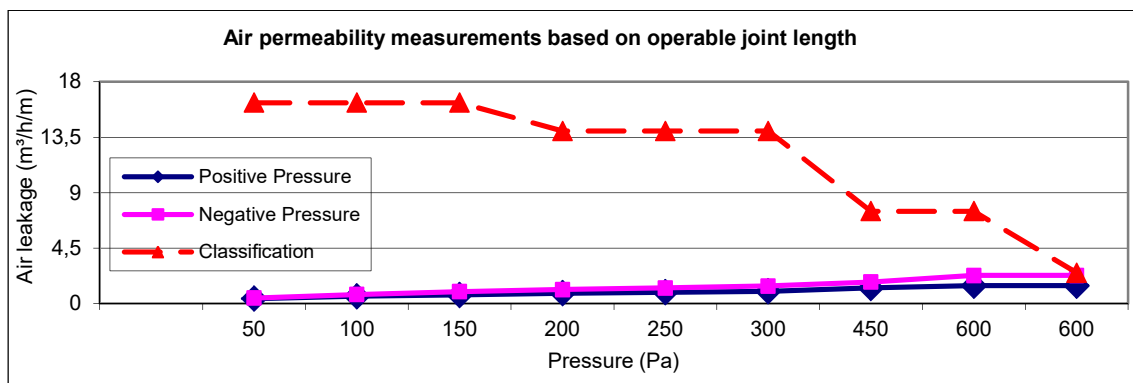
Air permeability measurements based on overall area for operable part;

POSITIVE PRESSURE		
Test Pressure (Pa)	Air Leakage (m³/h)	Air Leakage (m³/h/m²)
50	1,77	1,69
100	2,66	2,53
150	3,09	2,94
200	3,74	3,56
250	4,05	3,86
300	4,42	4,21
450	5,61	5,34
600	6,43	6,12

NEGATIVE PRESSURE		
Test Pressure (Pa)	Air Leakage (m³/h)	Air Leakage (m³/h/m²)
50	1,99	1,90
100	3,25	3,10
150	4,26	4,06
200	5,04	4,80
250	5,65	5,38
300	6,29	5,99
450	7,73	7,36
600	10,09	9,61

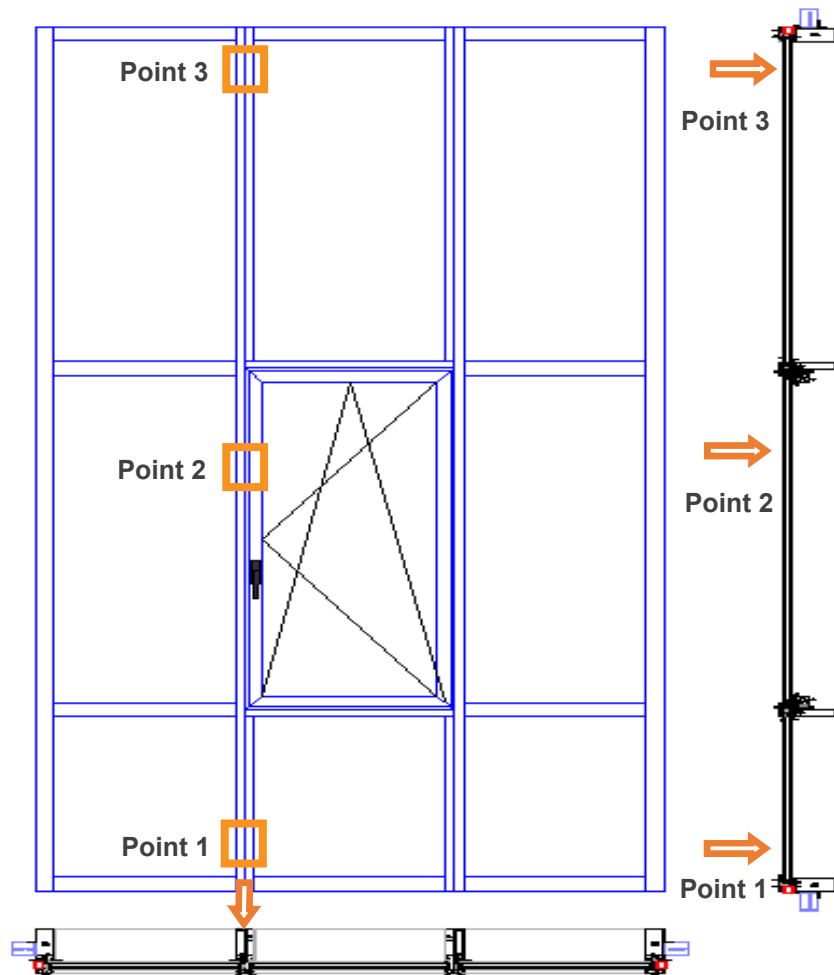
Figure 1. Positions of the deflection sensors on the specimen

Specimen dimensions and sensor placement coordinates;

X coordinates (mm)	Y coordinates (mm)
External Dimensions	2100	3800
Sensor 1 Replacement	700	100
Sensor 2 Replacement	700	1900
Sensor 3 Replacement	700	3700

Sensor positions: Vertical distance for mullion at middle axis, interstory height **L = 3800 mm**

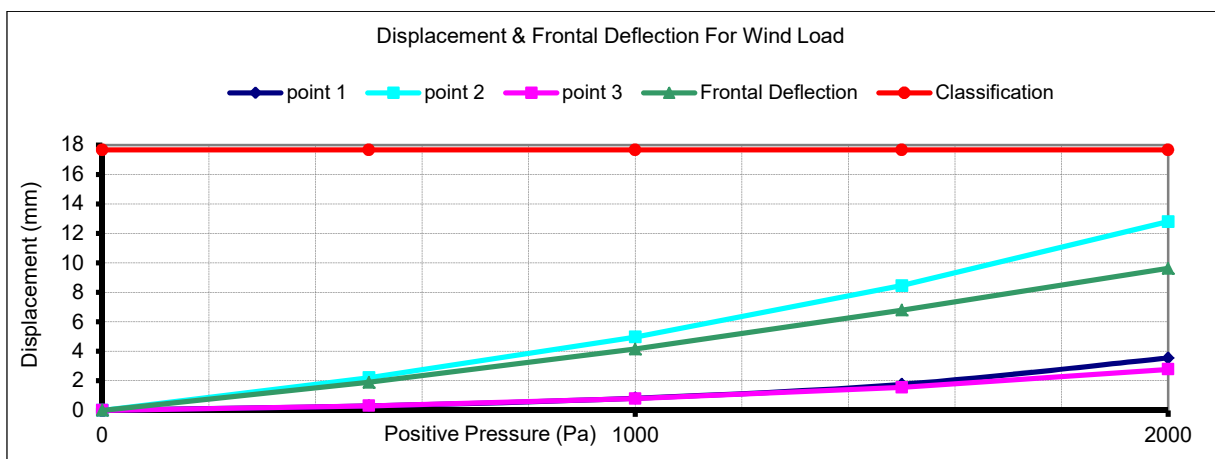
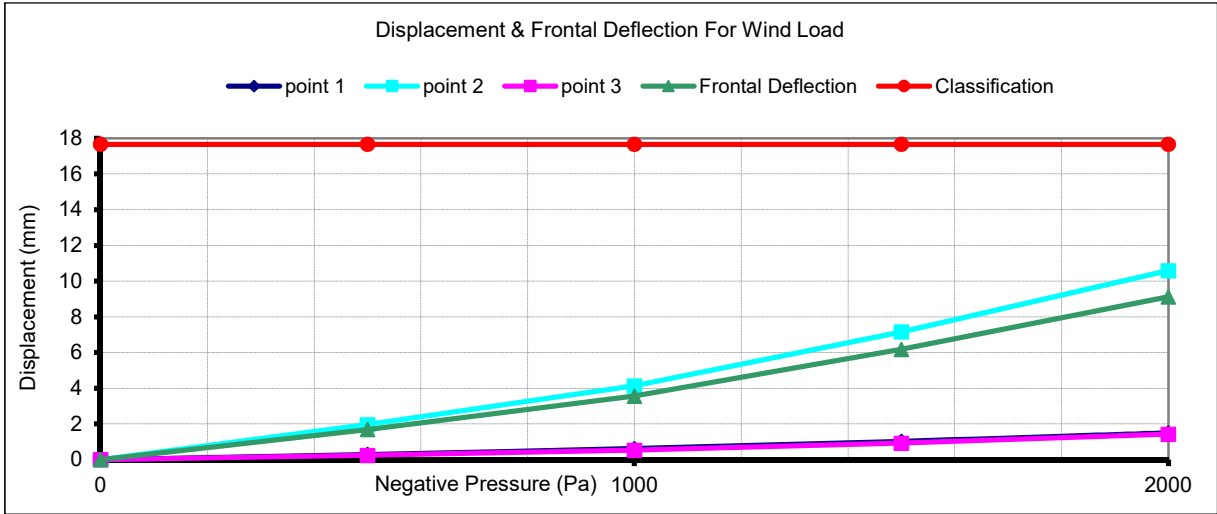
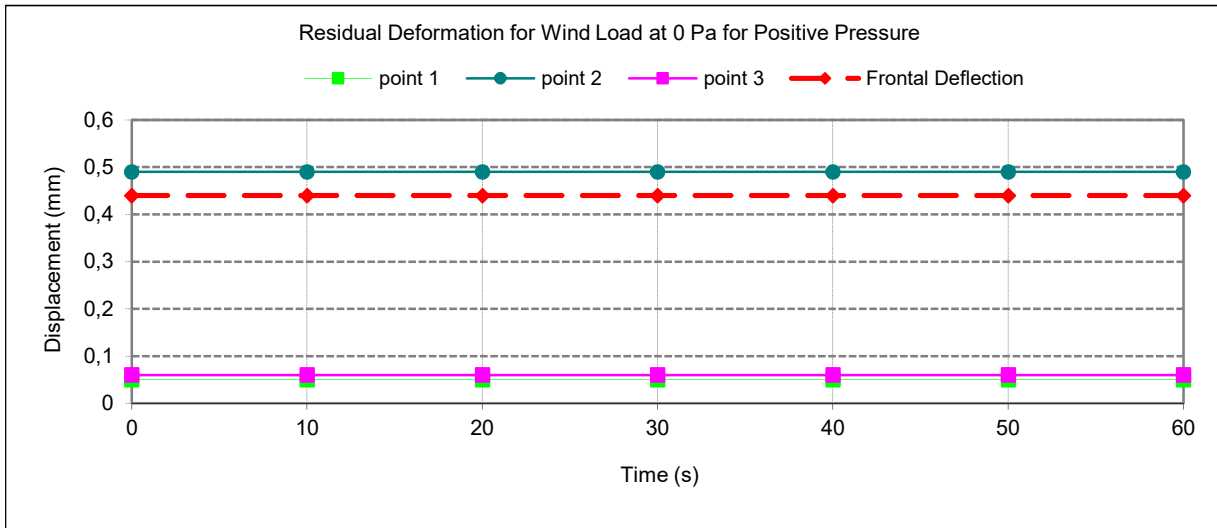
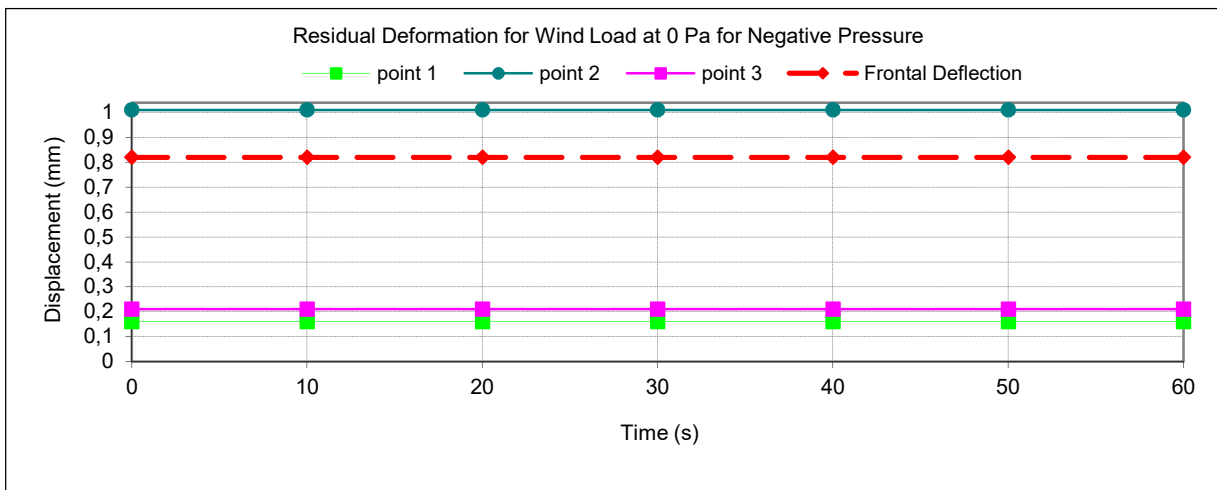
Frontal deflection measurement results on the vertical mullion;

Positive Pressure (Pa)	Point 1 (mm)	Point 2 (mm)	Point 3 (mm)	Frontal Deflection - d - (mm)	Negative Pressure (Pa)	Point 1 (mm)	Point 2 (mm)	Point 3 (mm)	Frontal Deflection - d - (mm)
0	0,00	0,00	0,00	0,00	0	0,00	0,00	0,00	0,00
500	0,30	2,21	0,30	1,90	500	0,29	1,97	0,25	1,69
1000	0,82	4,97	0,79	4,16	1000	0,62	4,14	0,53	3,56
1500	1,76	8,45	1,55	6,79	1500	1,03	7,16	0,93	6,18
2000	3,55	12,80	2,78	9,63	2000	1,50	10,59	1,43	9,12
0	0,05	0,49	0,06	0,44	0	0,16	1,01	0,21	0,82

RESISTANCE TO WIND LOAD (Design Load) EN 13830	Deflection < 17,66 mm at +2000 Pa and -2000 Pa	Positive Pressure	$\lambda_1 = 9,63 \text{ mm}$	OK
		Negative Pressure	$\lambda_2 = 9,12 \text{ mm}$	
RESISTANCE TO WIND LOAD (Extreme Load) EN 13830	There should be no damage at extreme load.	There was no damage observed at +1800 Pa (positive extreme load)		Extreme pressure could not reach to +3000 Pa, cause of the air leakage.
		There was no damage observed at -3000 Pa (negative extreme load)		OK

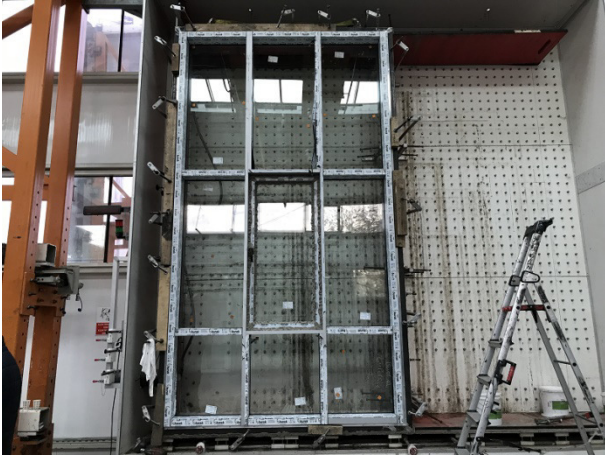
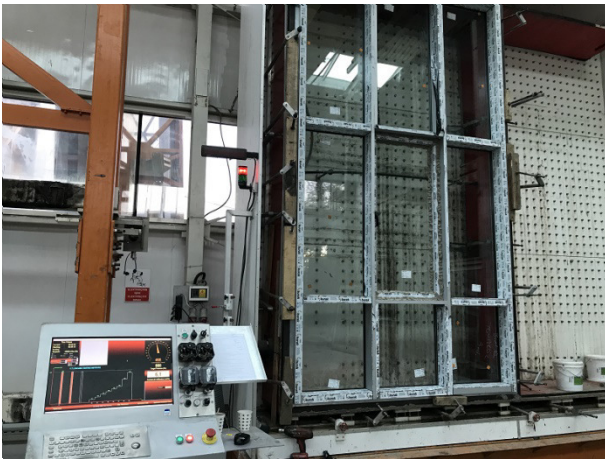
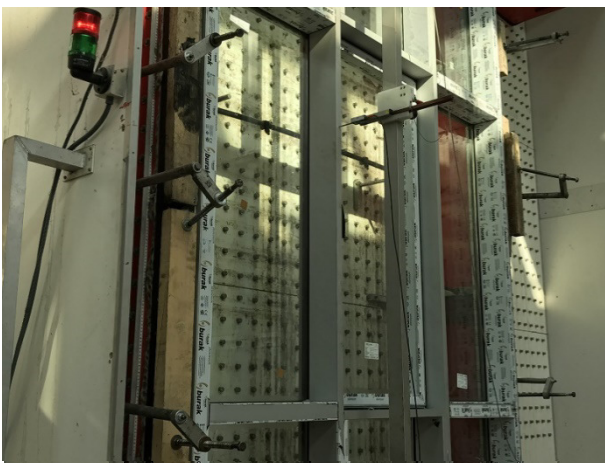
9. PHOTOS

BG 60

Kapaklı Cephe İçerisinde İÇeri Açılır Gizli Kanat (Inside Opening Hidden Vent In The Capped Curtain Wall)

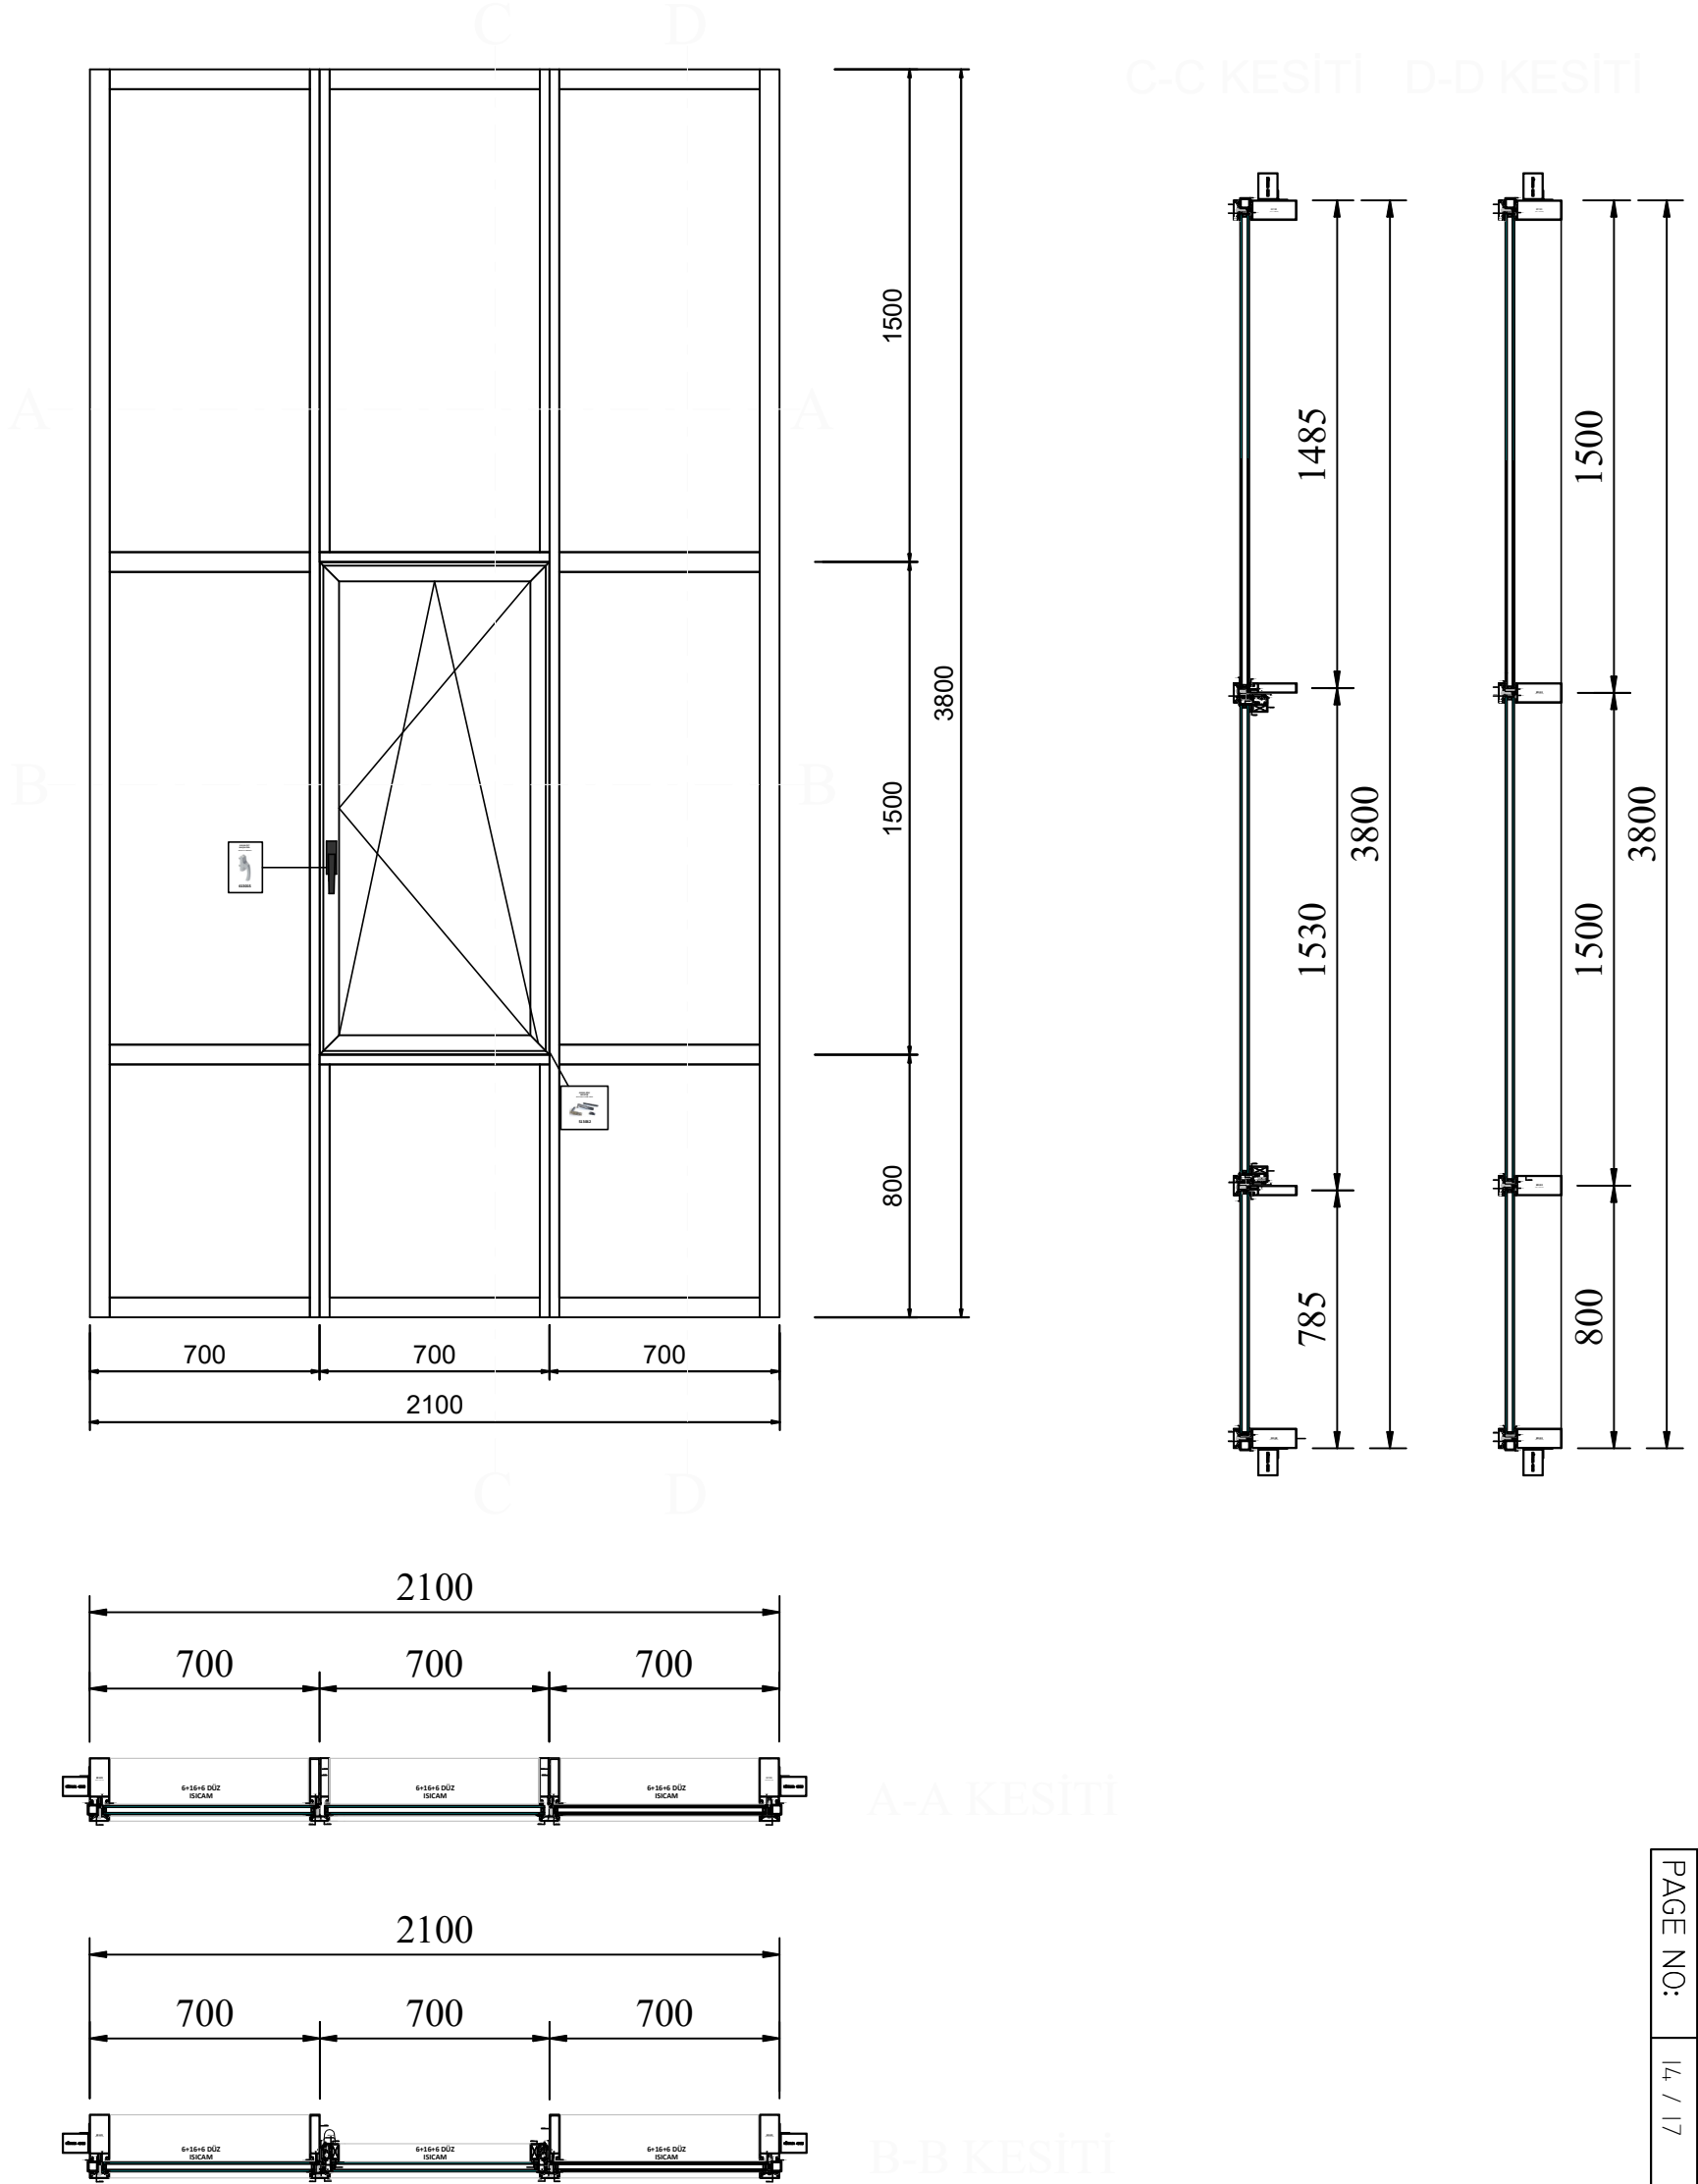
NOTIFIED BODY NO:	NB-2547	PROJECT	BG60 INSIDE OPENING HIDDEN VENT IN THE CAPPED CURTAIN WALL		
ACCREDITATION NO:	AB-0531-T		GENERAL PROFILE DETAILS		
REPORT NO:	020.973.1 / 2017	PROJECT CODE:	2017.885	DATE:	30.11.2017
PREPARED BY:	A.DINCEL	CLIENT:	BURAK ALUMINYUM SAN. VE TIC. A.S.	REV.NO:	A
CONTROL BY:	Ö.ARSLAN	EXPLANATION:	AIR PERMEABILITY, WATERTIGHTNESS AND RESISTANCE TO WIND LOAD

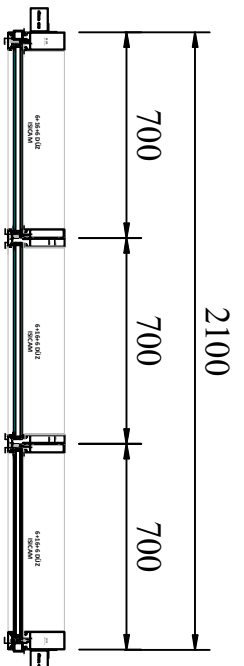
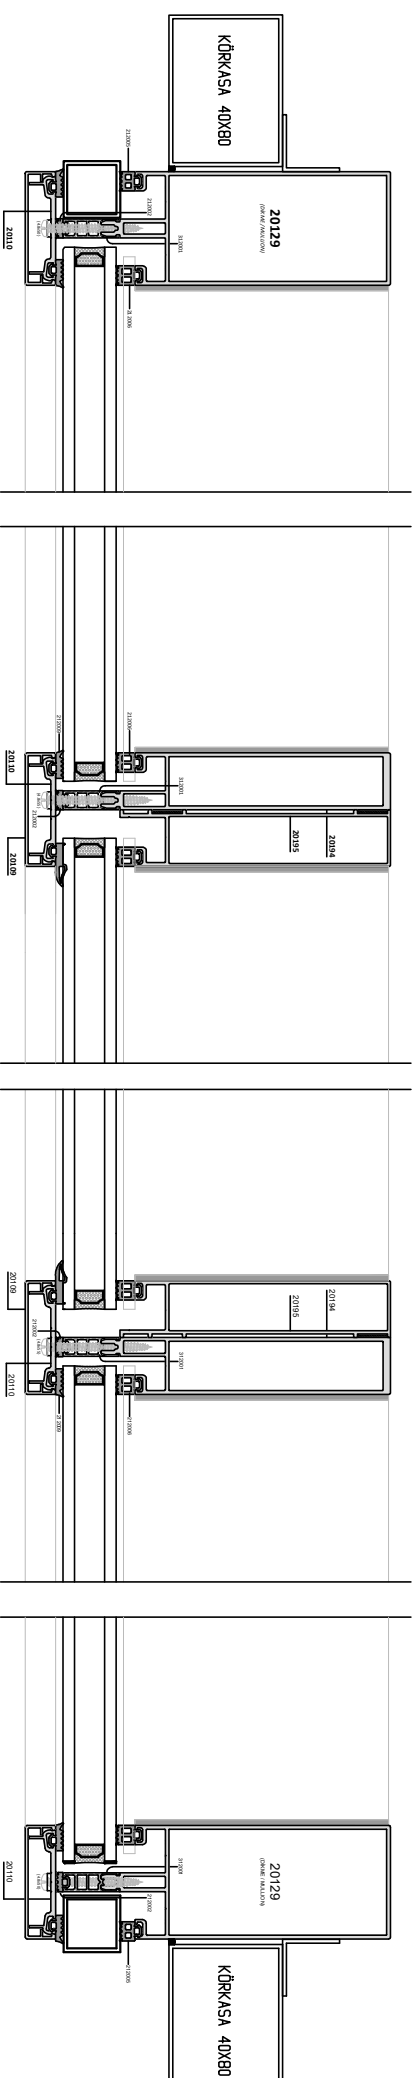
A-A KESİTİ

NOTIFIED BODY NO	NB-2547	DETAIL:	BG 60 INSIDE OPENING HIDDEN VENT IN THE CAPPED CURTAIN WALL
ACCREDITATION NO	AB-0531-T	SAMPLE NO	A-A SECTION & B-B SECTION / PLAN DETAILS
REPORT NO	020.973.1 / 2017	DATE	30.11.2017
PREPARED BY	A.DINCEL	REV.NO	A
CONTROL BY	Ö.ARSLAN	EXPLANATION	AIR PERMEABILITY, WATERTIGHTNESS AND RESISTANCE TO WIND LOAD

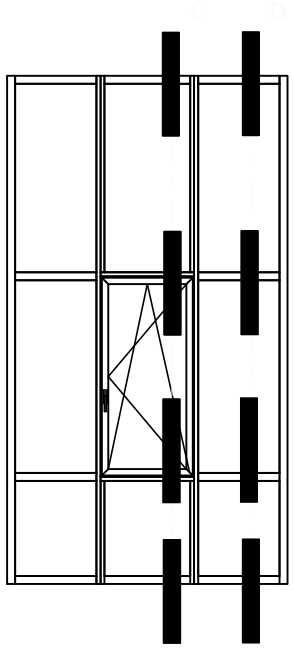
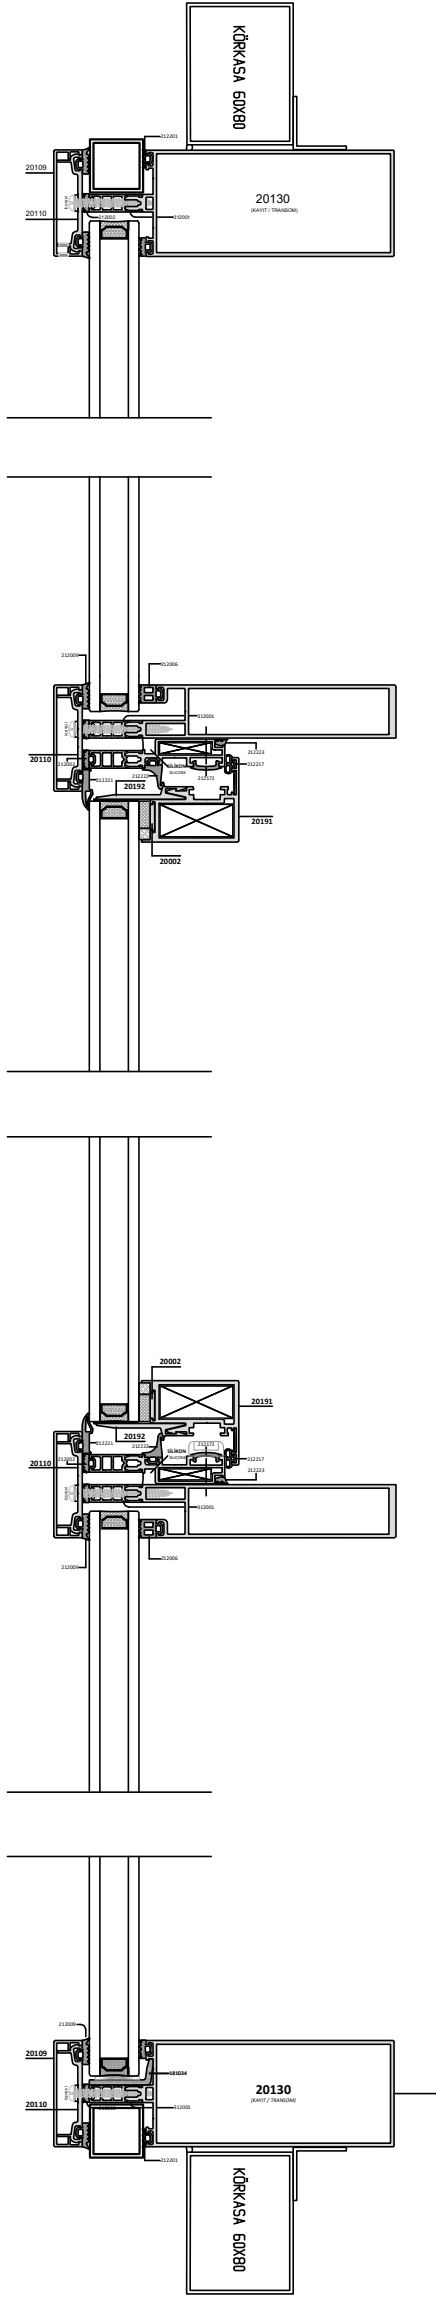
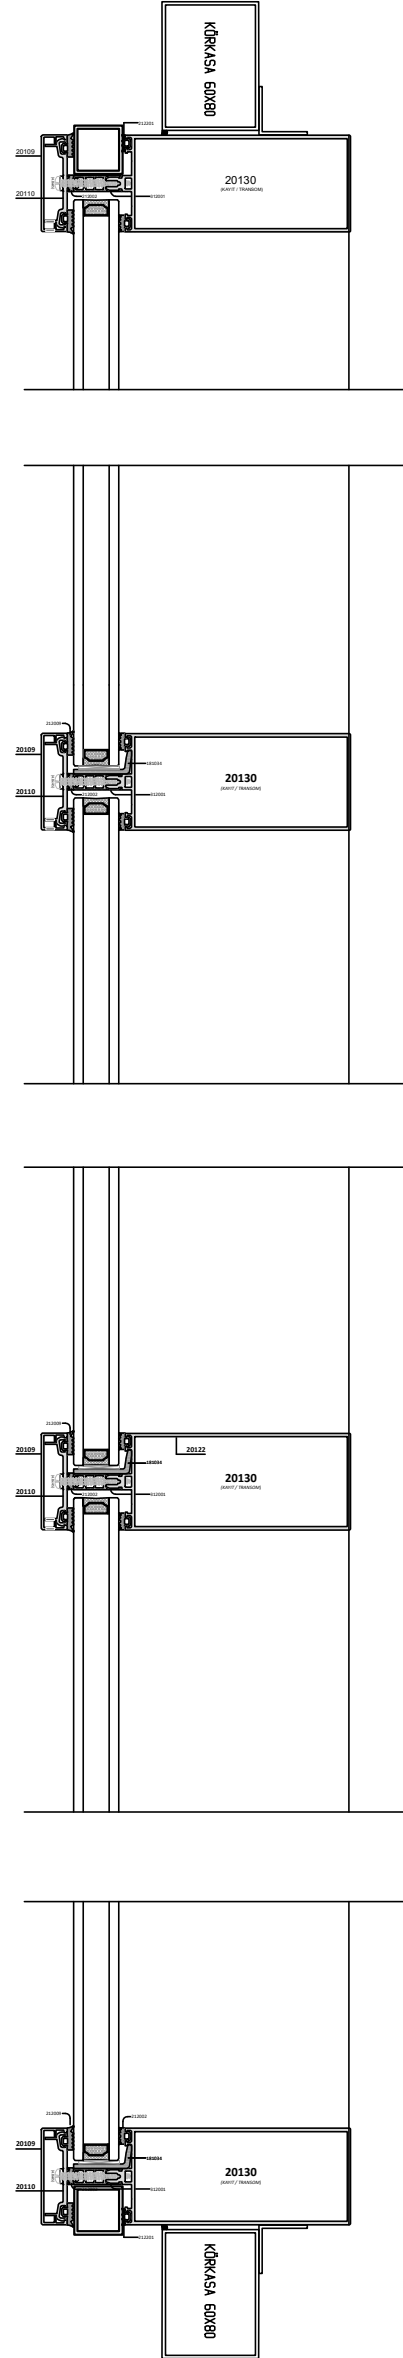
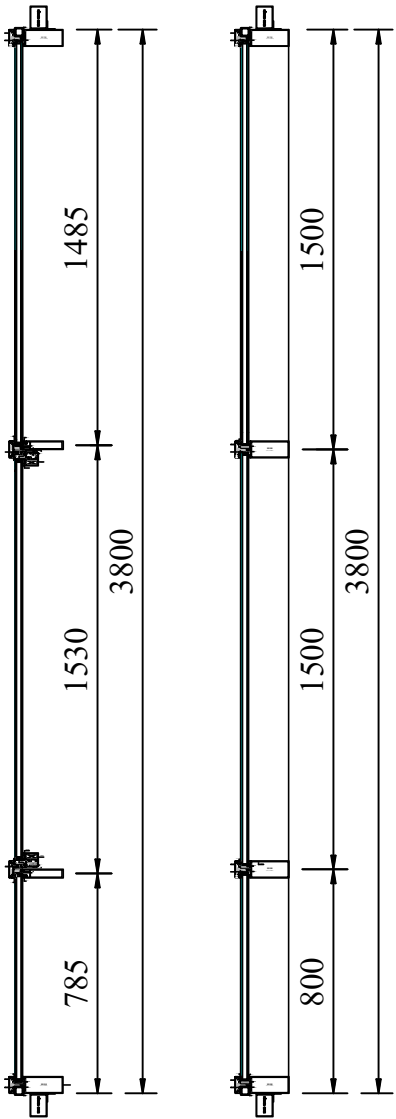
C-C KESİTİ

NOTIFIED BODY NO:	NB-2547	DETAIL:	BG60 INSIDE OPENING HIDDEN VENT IN THE CAPPED CURTAIN WALL C-C SECTION & D-D SECTION / SECTION DETAILS		
ACCREDITATION NO:	AB-0531-T	PROJECT CODE:	2017.885	DATE:	30.11.2017
REPORT NO:	020.973.1/2017	CLIENT:	BURAK ALUMINYUM SAN. VE TIC. A.S.	REV.NO:	A
PREPARED BY:	A.DINCEL	EXPLANATION:	AIR PERMEABILITY, WATERTIGHTNESS AND RESISTANCE TO WIND LOAD		
CONTROL BY:	Ö.ARSLAN

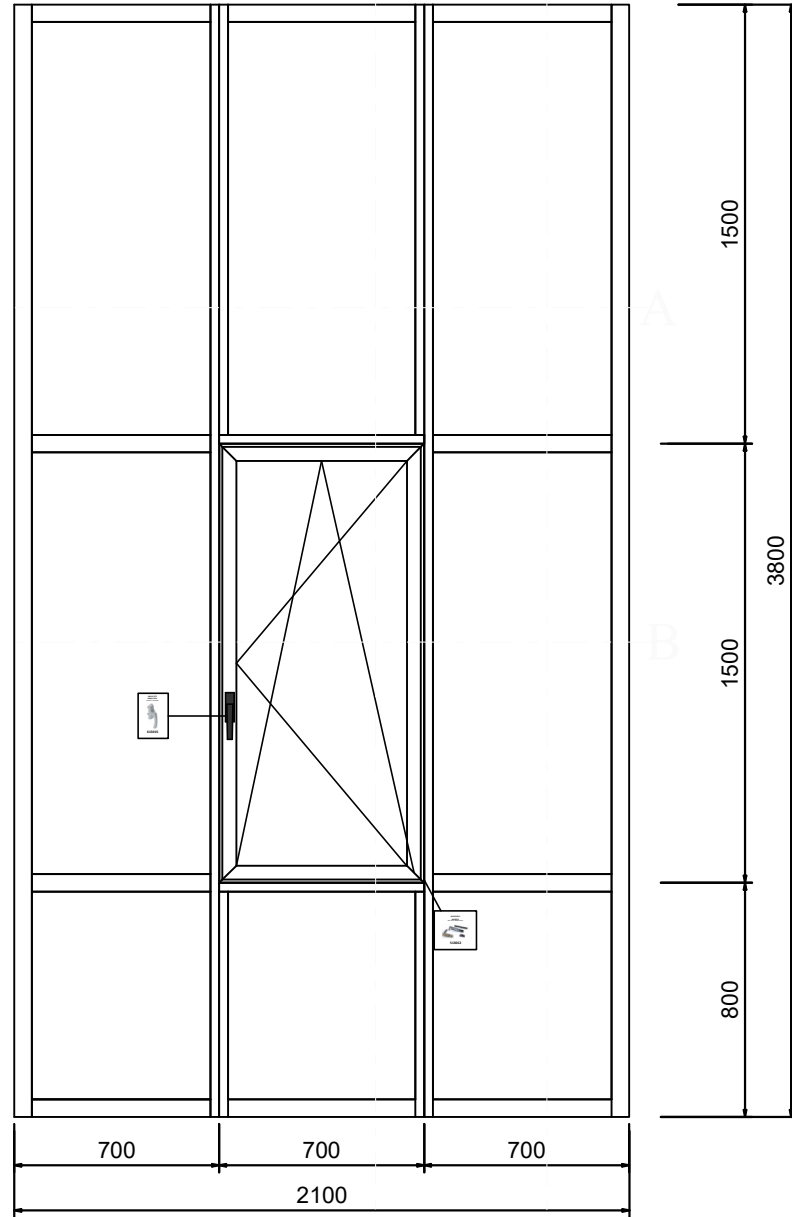
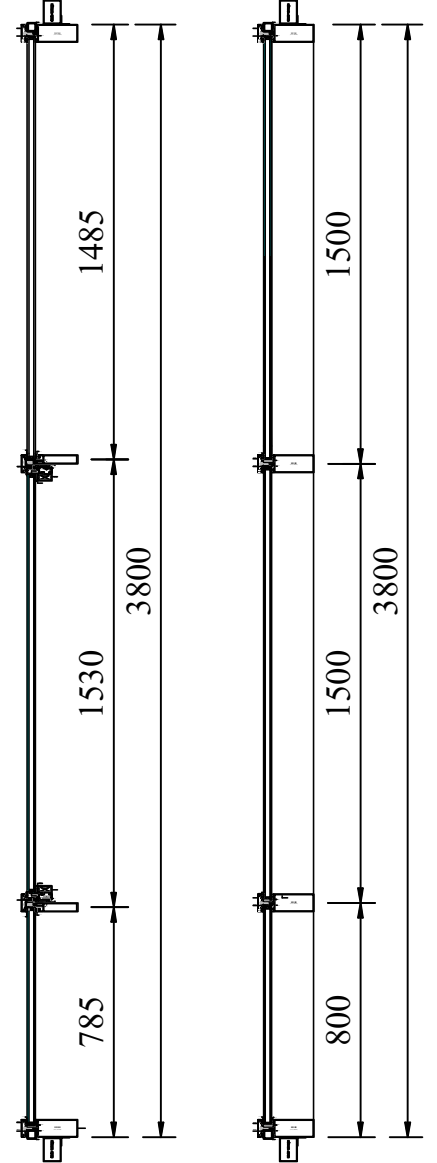
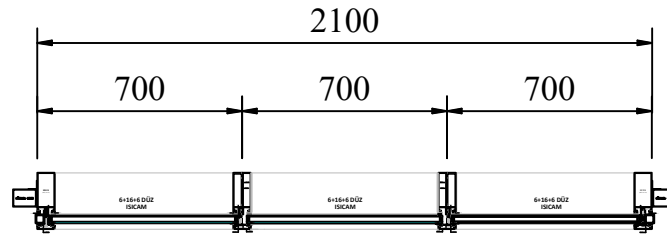
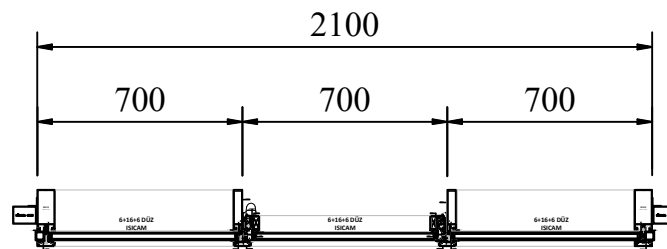
GIESSE
ÇİFT
MAÇALI
KOL
TWO-WAY
CREMONE

GIESSE
GİZLİ
MENTEŞE
SIDE
HINGE

NOTIFIED BODY NO:	NB-2547	DETAIL:	BG60 INSIDE OPENING HIDDEN VENT IN THE CAPPED CURTAIN WALL SASH MECHANISM DETAILS		
ACCREDITATION NO:	AB-0531-T	PROJECT CODE:	2017.885	DATE:	30.11.2017
REPORT NO:	020.973.1 / 2017	CLIENT:	BURAK ALUMINYUM SAN. VE TIC. A.S.	REV.NO:	A
PREPARED BY:	A.DINCEL	EXPLANATION:	AIR PERMEABILITY, WATERTIGHTNESS AND RESISTANCE TO WIND LOAD		
CONTROL BY:	Ö.ARSLAN
