DENEY SERTİFİKASI / Test Certificate

**Ürün Tipi Kimlik Kodu / Identification Code of the Product Type :** BS 66 - Sliding Window System

## TEST REPORT

**Product** : BS 66 Sliding Window System

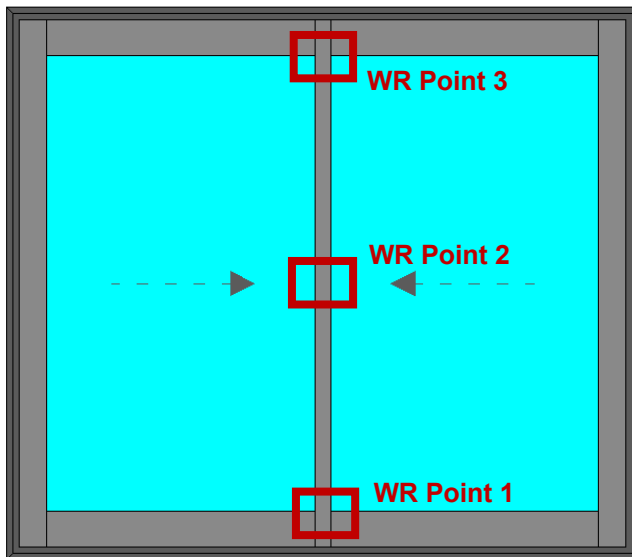
*Specimen dimensions and sensor replacement coordinates;*

X coordinates (mm)	Y coordinates (mm)
<b>External Dimensions</b>	1600	1400
<b>Sensor 1 Replacement</b>	800	70
<b>Sensor 2 Replacement</b>	800	700
<b>Sensor 3 Replacement</b>	800	1330

**Frontal deflection measurement results on the vertical profile;**

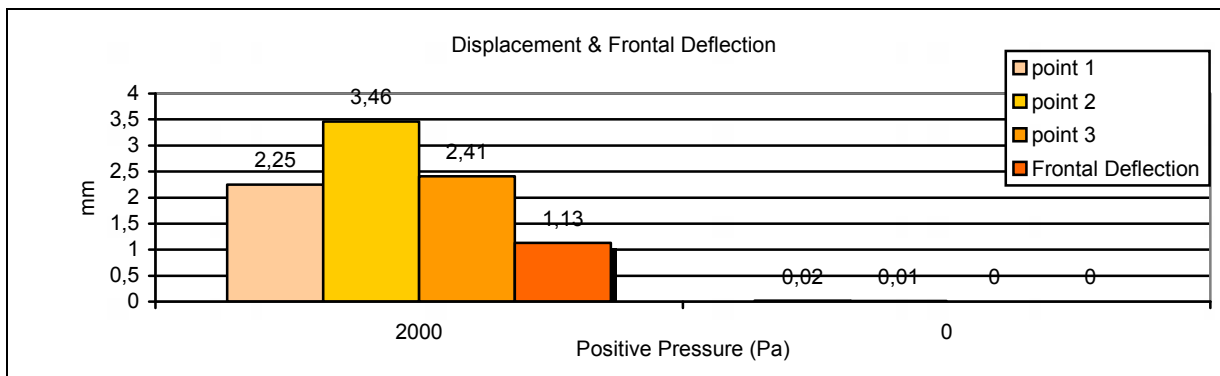
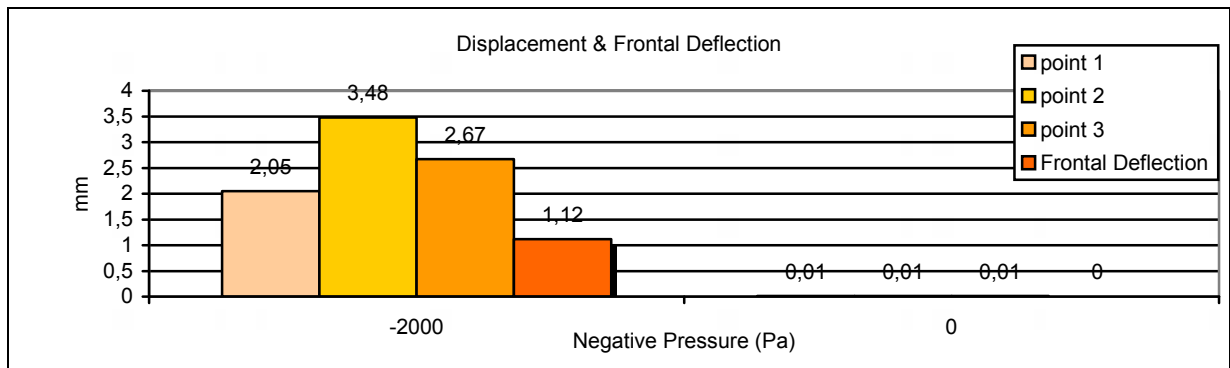
Positive Pressure (Pa)	Point 1 (mm)	Point 2 (mm)	Point 3 (mm)	Frontal Deflection (mm)
2000	2,25	3,46	2,41	1,13
0	0,02	0,01	0,00	0,00

Negative Pressure (Pa)	Point 1 (mm)	Point 2 (mm)	Point 3 (mm)	Frontal Deflection (mm)
2000	2,05	3,48	2,67	1,12
0	0,01	0,01	0,01	0,00

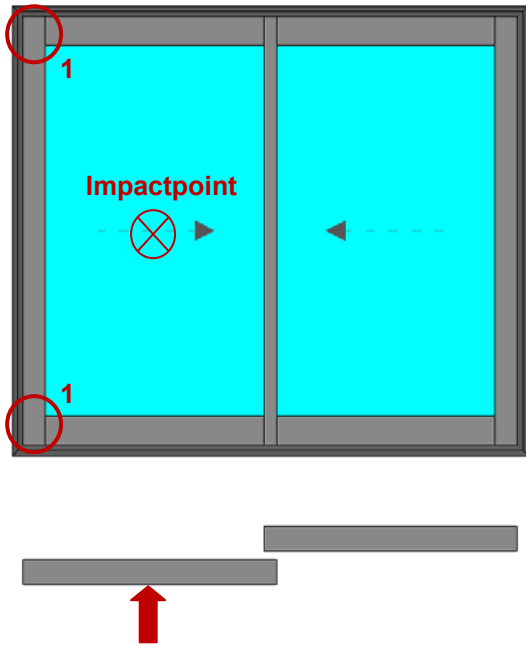
There were observed deformations on the junction of the corners between horizontal and vertical profiles.<sup>1</sup>

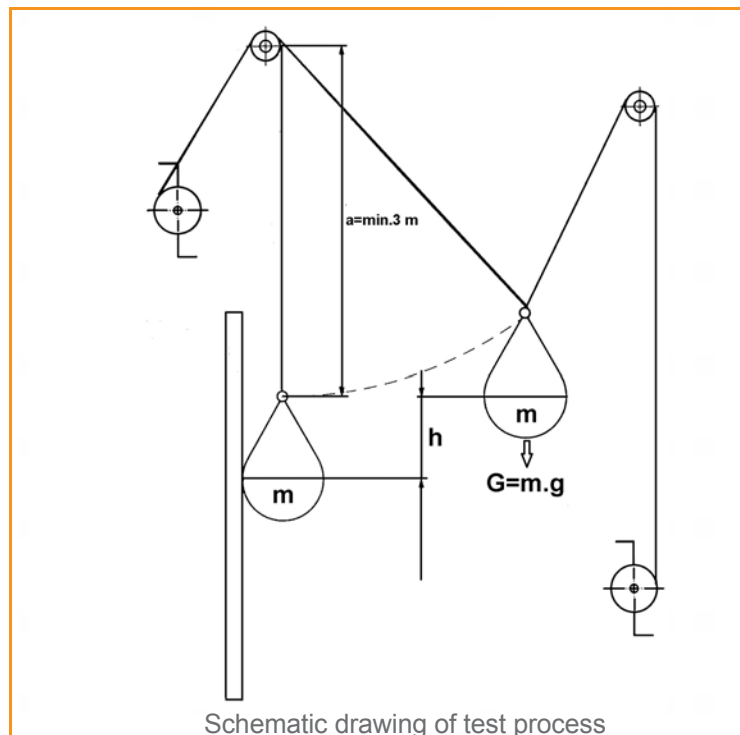
7.8.1. Test Mechanism

This test was performed in compliance with EN 13049. Thus, soft body impact testing shall be carried out by means of a suspended weight a cord at least 3 m long to swing in pendulum movement until it hits the test specimen normal to its face. The impact body is occurred by two 3.50-R8 4 PR rubber tire and a steel frame. Totally weight of impact body is 50 kg. Internal pressure of tires were adjusted to 0,35 MPa (0,50 psi) before the test.

Schematic drawing of test process

For each impact ;  $m = 50 \text{ kg}$  ,  $g = 10 \text{ m/s}^2$

Impact 1	Impact 2	Impact 3	Impact 4	Impact 5
$E = m.g.h$	$E = m.g.h$	$E = m.g.h$	$E = m.g.h$	$E = m.g.h$
$E = 50.10.0,2$	$E = 50.10.0,3$	$E = 50.10.0,45$	$E = 50.10.0,7$	$E = 50.10.0,95$
E = 100 Joule	E = 150 Joule	E = 225 Joule	E = 350 Joule	E = 475 Joule
